**PHYSICO-CHEMICAL ANALYSIS  
OF THE DRINKING WATER FROM  
THE OLD PUBLIC FOUNTAIN-MONUMENT  
AT KADIN MOST (NEVESTINO), BUILT  
BY THE 13<sup>TH</sup> RILA INFANTRY REGIMENT IN 1932**  
**(In honor of the 140<sup>th</sup> Anniversary of the Establishment  
of the 13<sup>th</sup> Rila Infantry Regiment)**

**Abstract.** In the village of Nevestino (old Kadin Most) on Str. Mitko Palauzov No. 12 has a fountain built by the 13th Rila Infantry Regiment in 1932. In addition to providing water for itself, with this fountain the regiment has done a social deed for the local population, because before the water supply and sewerage network was built, the fountain supplied half of the village with fresh, high-quality and very cold water even in the summer. And now, every summer, in a water crisis, the tap provides the people of the village with fresh water. There is no information about the fountain in the institutions, as well as literature data about it. This article is its first documentation as an object and monument of culture. The water from both fountains meets the drinking water requirements for the studied indicators. It does not contain heavy metals, nitrates, nitrites, arsenic, pr

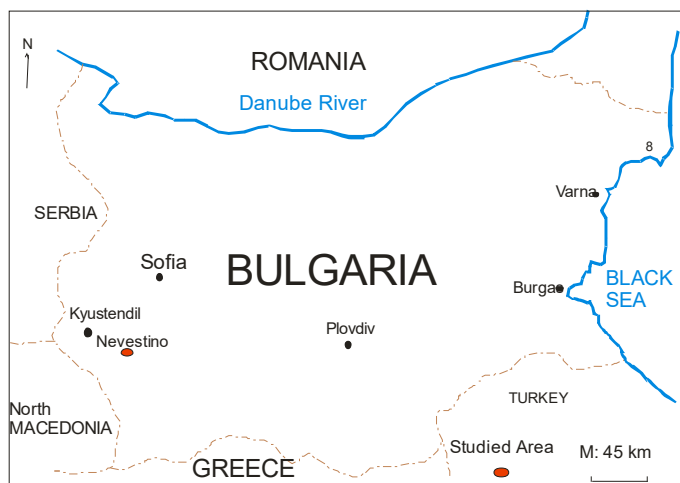
**Figure 1.** Location of the studied area

In the village of Nevestino (old Kadin Most) on Str. Mitko Palauzov №12 is a fountain, which was built by the 13th Rila Infantry Regiment in 1932. Coordinates Location: 42°15'13.44"N, 22°51'29.65"E, Altitude: 444 m (Figs. 1,2,3).

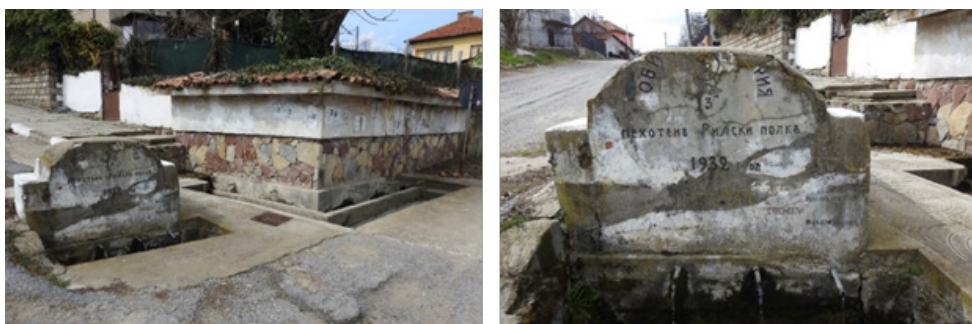
**Figure 2.** Old fountain-monument (left) and new fountain (right)

**1. Water analyses.** From Tables 1 and 2 it can be seen that the water from the two fountains is the same. The values of the measured physico-chemical parameters are almost identical. The new fountain, built in the 80s of the 20th century, has almost twice the flow rate, indicating that most of the water from the underground stream has been captured. Accordingly, the temperature is slightly higher, due to the different way of building and using newer materials. Acidity, redox potential, electrical conductivity and mineral salt content are almost the same. One indicator of clean water is the equality between the values of mineral salts and dissolved solids (Rusydi, 2018). Hardness and total alkalinity are also of the same value. In the water of both fountains there are indications of small amounts of bromine, which is often part of the mineral salts coming from the water when passing through the soil horizons. According to the measured physical and chemical parameters, the water is of good quality for drinking and domestic water, for domestic animals and livestock. After drainage of the water from the two fountains, it continues its path uncontaminated through the azonal alluvial soils (FAO-ISRIC-IUSS, 2006) on the 1st and 2nd floodplain terraces of the Struma River, feeding the subordinate horizons of the agricultural areas located along its flow.

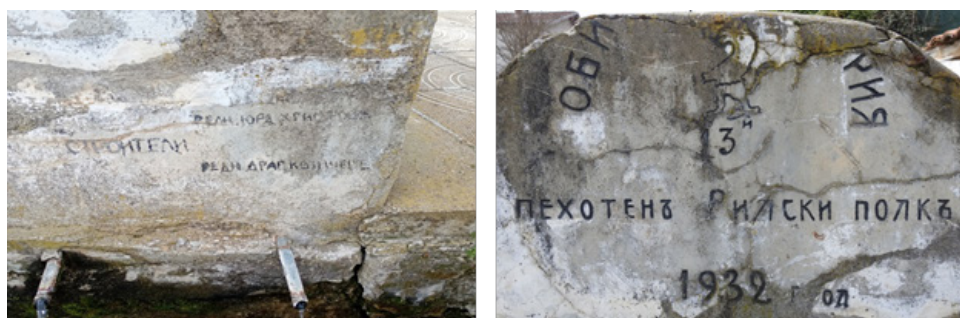
**Figure 3.** Inscriptions and symbols

## **3. Inscriptions and symbols.**

The inscriptions are black and partially obliterated:

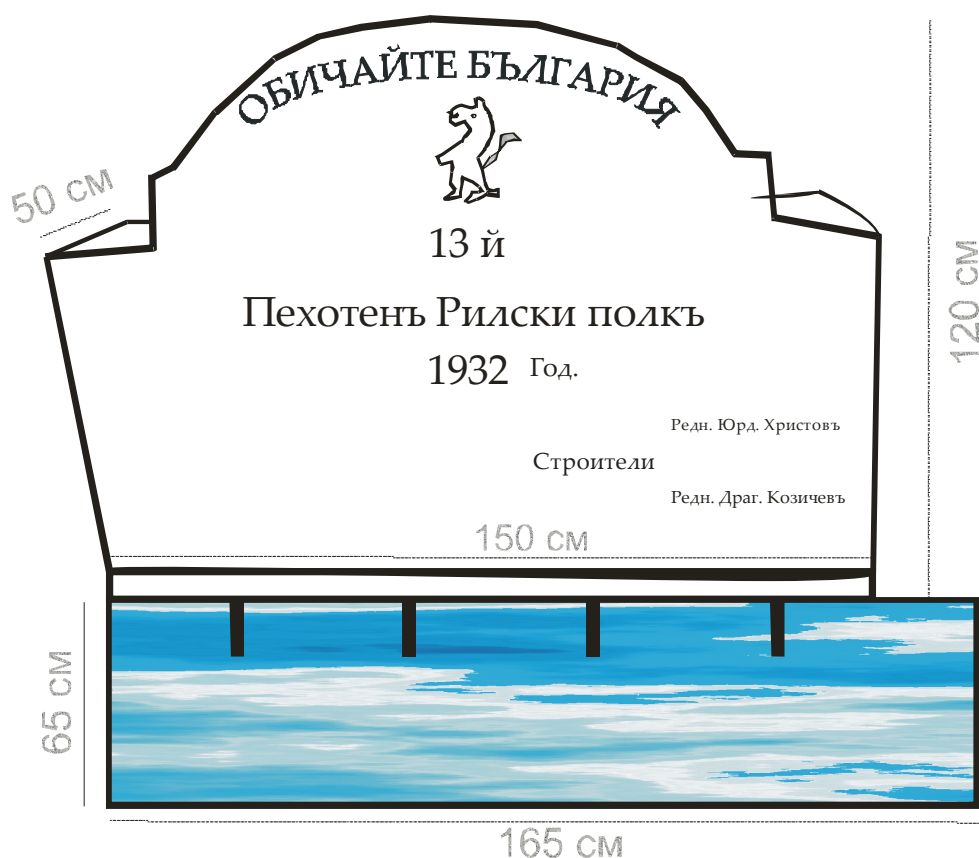
The dimensions of the fountain are as follows:

Length 150 cm

Width 50 cm

The arch begins after a 20 cm threshold, followed by a smaller step 13 cm high and 4 cm wide.

The height from the lowest to the highest point is 95 cm, but the upper section is missing—as evidenced by the inscription—meaning the actual height is greater, likely 120 cm.

Trough dimensions: 165 x 65 cm.

Features 3 spouts (out of a total of 4), with a length of 15 cm and a depth of 50 cm; equipped with water inlet and outlet connections.

Material: stone and cement; features built-in reflectors on the front-left and at the rear.

**Figure 4.** Dimensions and a project proposal for restoration of the monument

Includes restoring the fourth spout, repairing the structure and rendering, and refreshing the exterior finish (white). Restoration of the fountain to include the original inscriptions and symbols in black on its facade. Cleaning and repair of the basin. Arrangement of a seating area – installation of a wooden bench (Fig. 4).

The memorial fountain is currently in poor condition and requires restoration and preservation, and the institutions need to help to be identified, documented and included in the list of immovable cultural values and cultural monuments on the occasion of its 100th anniversary and in connection with the 140th anniversary of the establishment of the 13th Rila Infantry Regiment.
